# Manhole Inspection Summary

Manhole # S15C\_\_022MH

Insp Date: **2/4/08 12:55 PM**

**Location** Address: **2603 LAURETTA-FRANKLIN** Cross Street: **ASHBURTON ST**

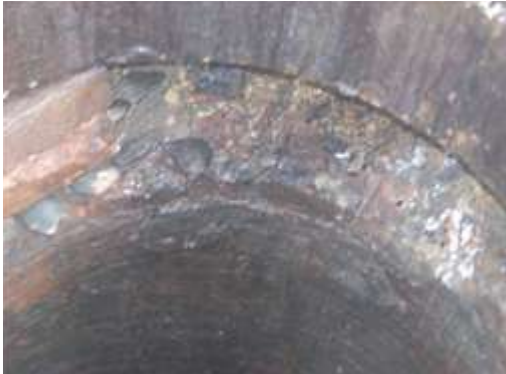
Defect 3

CHIMNEY INFILTRATION

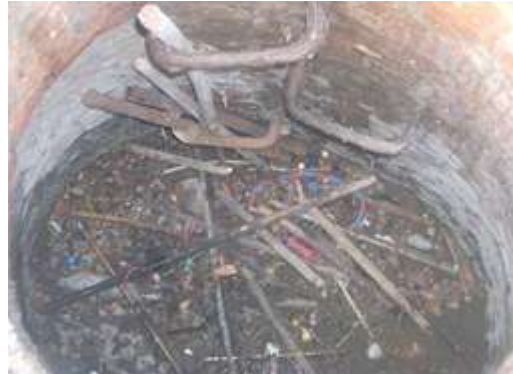
Defect 2

CORRODED STEPS

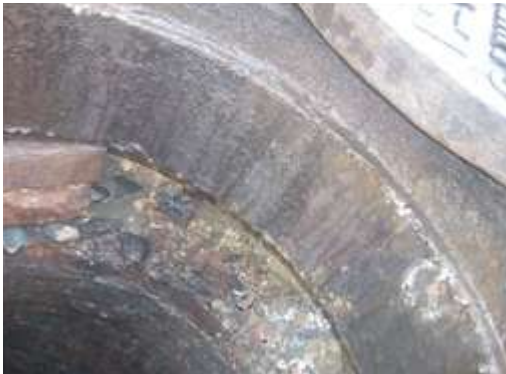
Defect 1

**Chimney / Frame Adjustment** ☒ Exists Material: **Brick and Concrete** ☐ Parged Height: **6** (in.)  
Condition: ☐ Sound ☐ Cracked ☐ Root Intrusion ☐ Loose Brick ☒ **Deteriorated**  
Infiltration: ☐ None ☒ **Joint** ☐ Cracks ☐ Mortar ☐ Roots ☐ Wall

CHIMNEY DETERIORATED

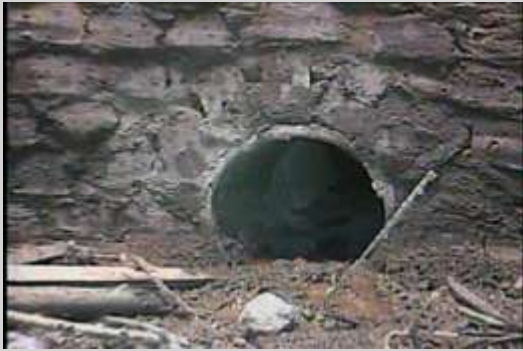
12 O'Clock Outflow

8 in. Circular Gravity Sewer  
Pipe Out @ 12 O'Clock
